Repair Strategies

Tens of thousands of homes in Gaza remain in ruins following Israel's 2008–2009 military assault, Operation Cast Lead. Nearly **50% of Gaza residents are unemployed**, **80% of families depend on international aid for their survival**, and a siege of Gaza's borders has blocked access to building materials. This is a humanitarian crisis.

How to Read This Report

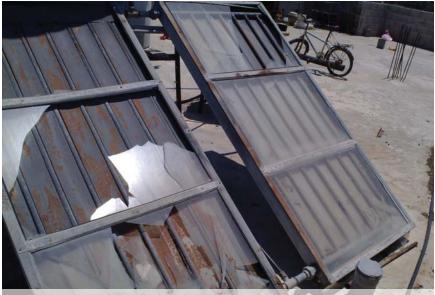
Damaged Solar Hot Water Units in Gaza City | UUSC

The most overt damage to the domestic water supply was to the elevated water storage tanks and their associated solar water heating system. Most of the households are using one to three water storage tanks with the capacity of 1000 liters each. These tanks are locally manufactured of PVC and placed on the top of buildings together with a solar water heating system.

\$7,000 could replace broken solar water heaters and water storage tanks in 40 homes.

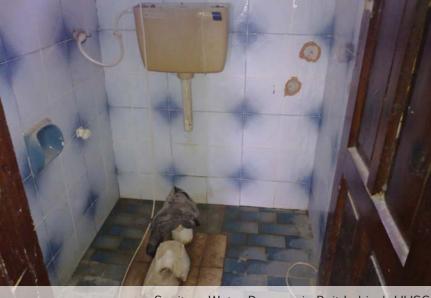
In Beit Lahia, no damage was found to the Network.

Sanitary Water Damage in Beit Lahia | UUSC

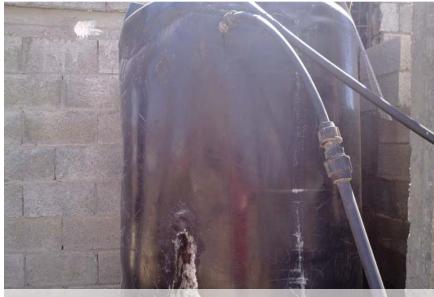
In Gaza City, 51% of households were reported to have damage to the connection of the house sanitary fixtures to the street sewer or septic tank. However, repairs were made immediately after the war by family members. These repairs were done quickly and may not be adequate as a long term solution.

Sanitary Water Damage in Gaza City | UUSC

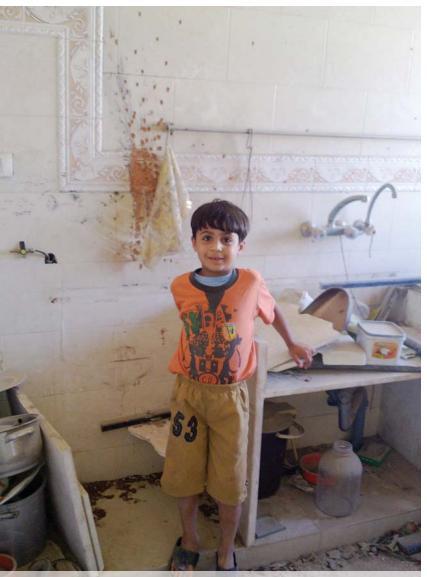
Damaged Kitchen in Gaza City | UUSC

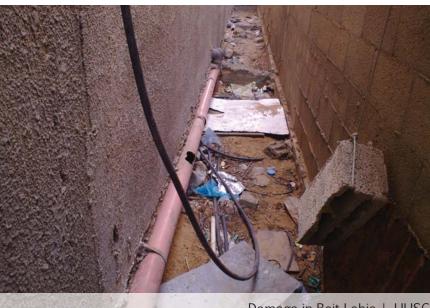
Damage in Beit Lahia | UUSC

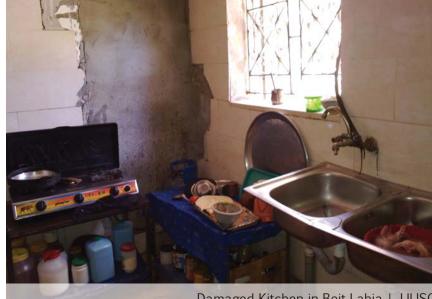
Damaged Kitchen in Beit Lahia | UUSC

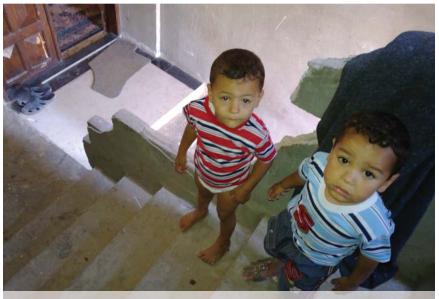
Damaged Stairs in Beit Lahia | UUSC

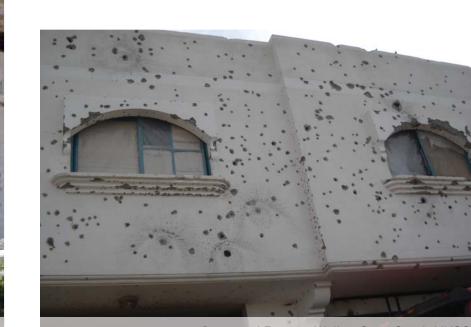
Damaged Exterior Wall in Gaza City | UUSC

Access to high exterior walls, over 9meters high, requires scaffolding. It typically costs \$50 to rent scaffolding for a typical facade.

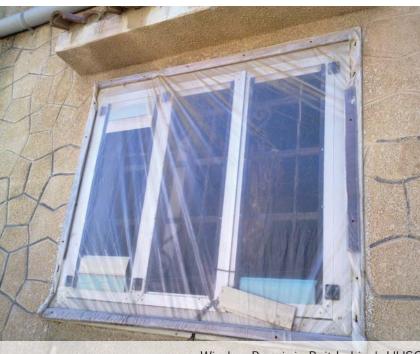
Window Repair in Beit Lahia | UUSC

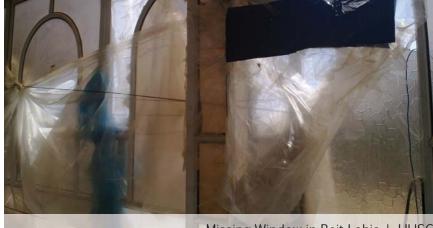
Missing Window in Beit Lahia | UUSC

- $\cdot\,$ Double glazing is costly, not available and would require replacing the frames
- · Israeli glass is inexpensive and available in Gaza

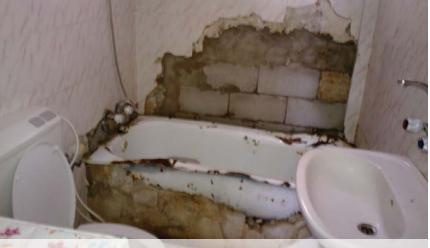
Damaged Bathroom in Gaza City | UUSC

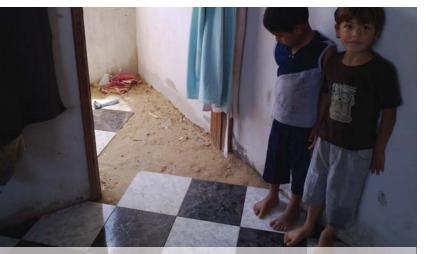
Despite availability, tile installation practices are often inadequate. Floor tile is set on sand over concrete, rather than a setting medium such as mortar or grout. Also, many homes have no floor slab, and tile is thus laid directly on the sand/ dirt below. Ants, animals, and moisture can easily make their way in.

Damaged and Missing Floor Tiles in Gaza City | UUSC

Install a waterproof membrane (heavy plastic) over the subfloor, concrete, wood, or directly at-grade if there is no subfloor

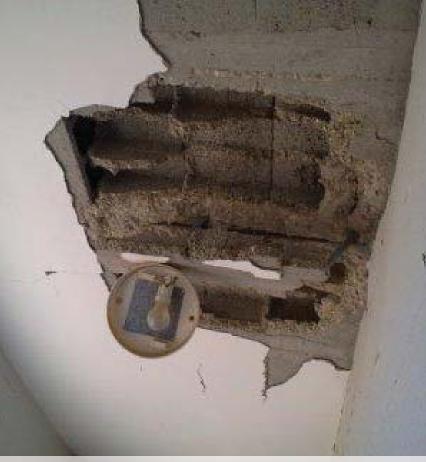
Interior Plaster Damage | UUSC

- Paint can be purchased locally
- \cdot \$30 to \$40 per 4m²
